Investigation And Appraisal Of The Performance of Cement Treated Bases As Used In Composite Pavements In California

June 1968

State of California  
Department of Public Works  
Division of Highways  
Materials and Research Department

Final Report

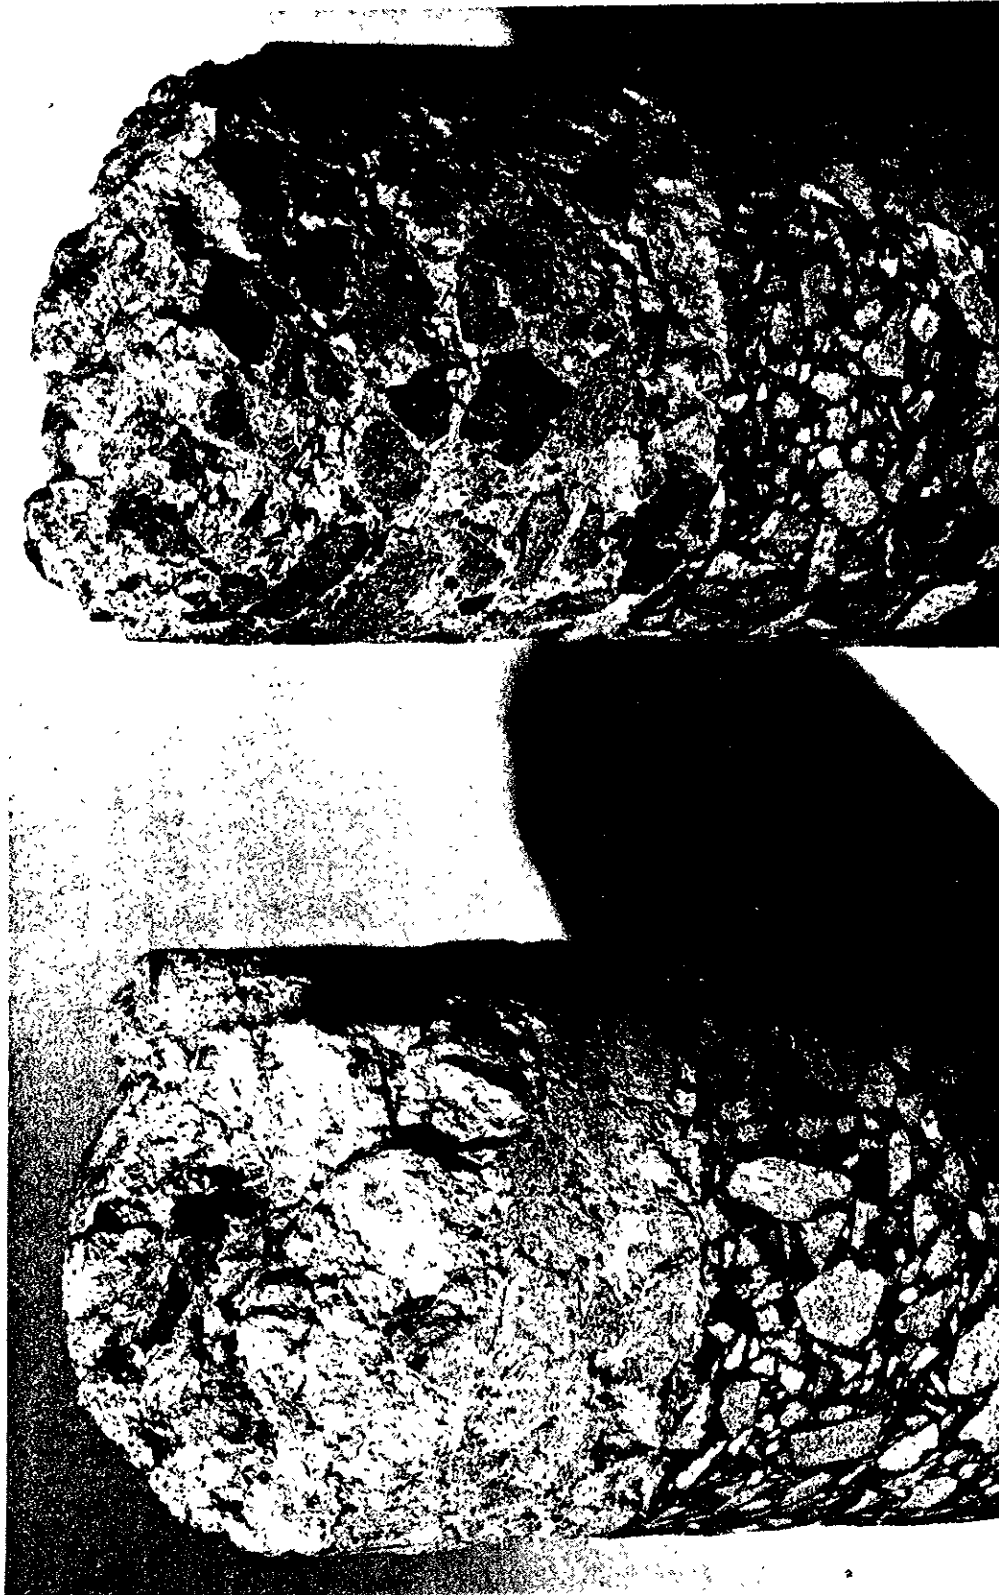
Figure 1

CLASS "A" CTB CORES  
Project 04-Mrn-17 - 0.3 / 2.3

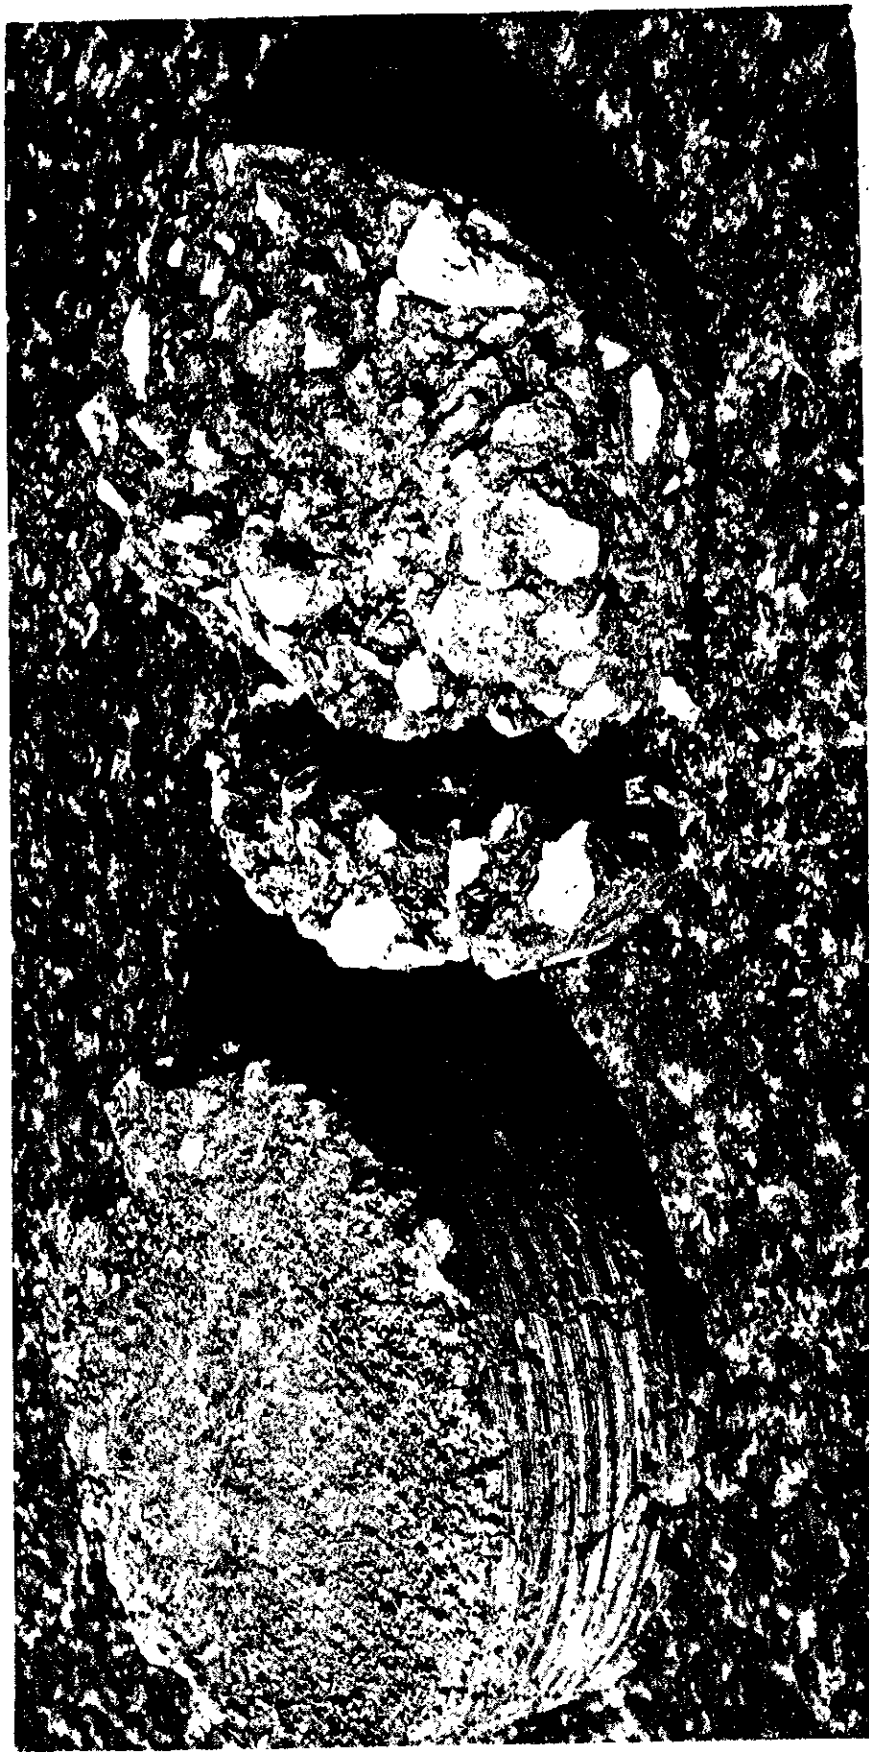
Figure 2

CLASS "A" & CLASS "B" CTB CORES

Project 04-Mrn-17 - 0.3/2.3

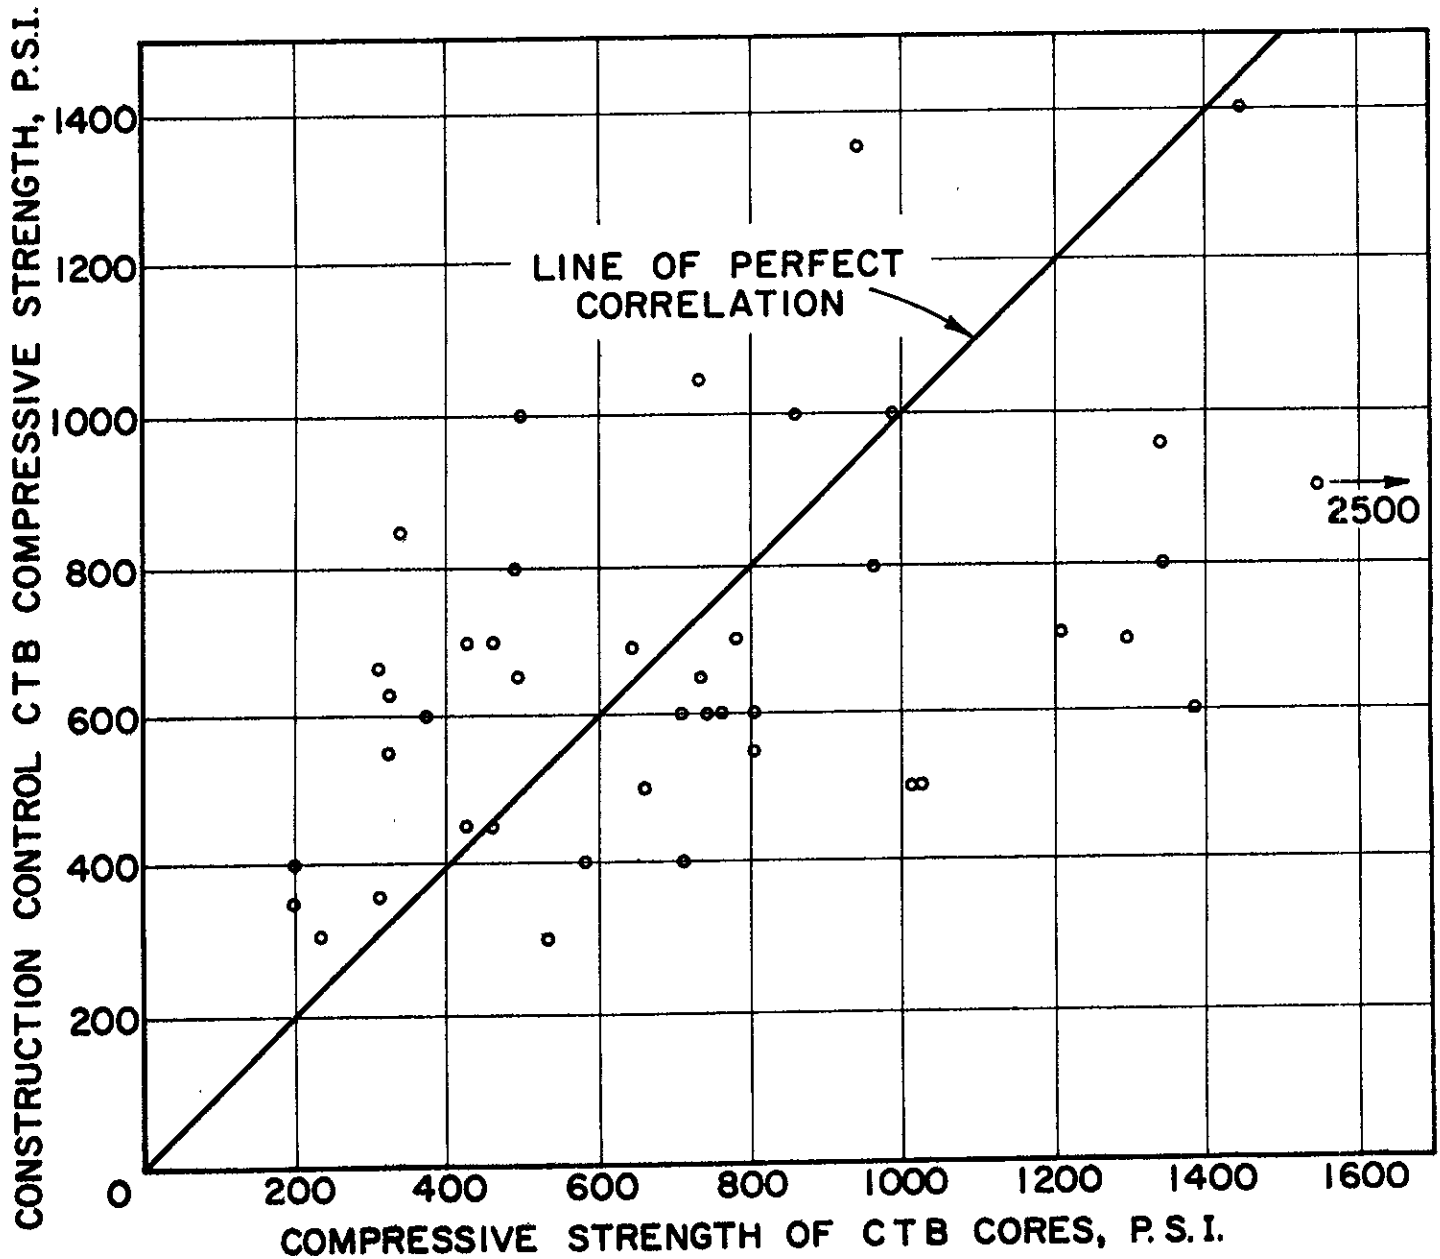
Figure 3

# COMPARISON OF COMPRESSIVE STRENGTH OF CONSTRUCTION CONTROL SAMPLES WITH THAT OF THE FIELD CORES

1. CTB CORES WHICH DISINTEGRATED DURING CORING WERE GIVEN AN ARBITRARY COMPRESSIVE STRENGTH OF 200 P.S.I.
2. EACH POINT REPRESENTS THE AVERAGE COMPRESSIVE STRENGTH OF FOUR 4 INCH DIAMETER CORES.

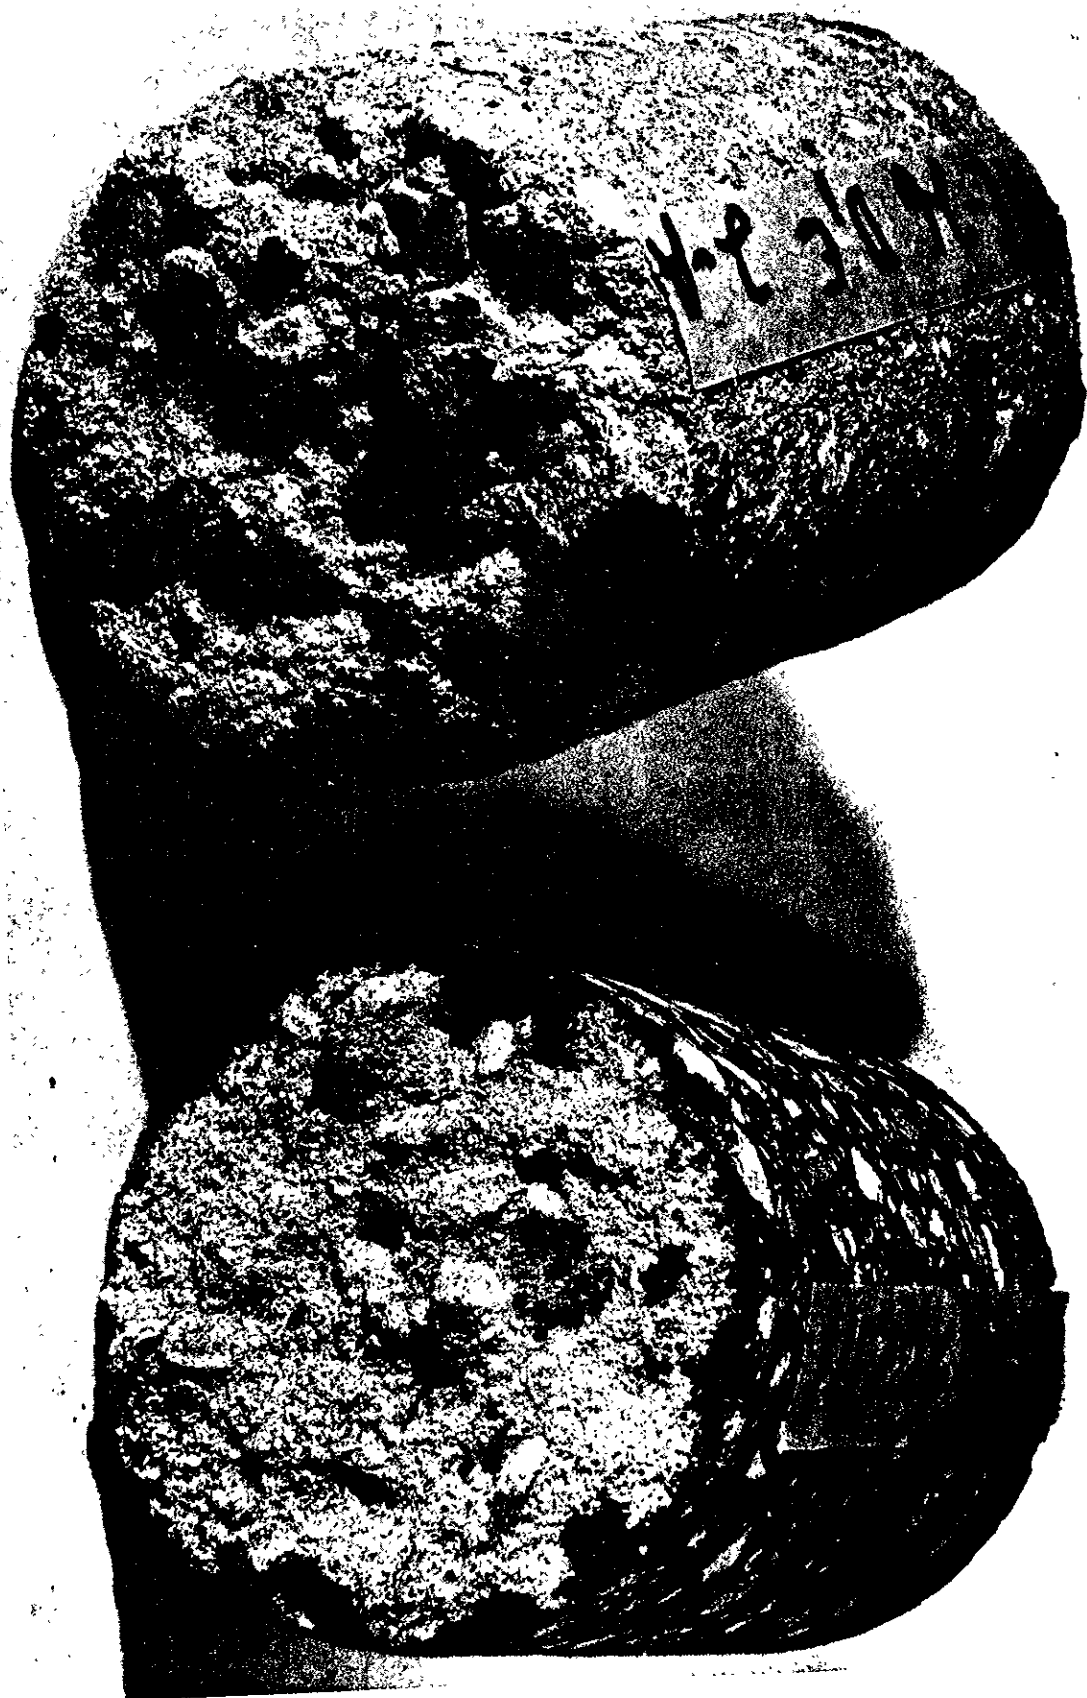
Figure 4

**SHEAR PLANE IN CLASS "A" CTB**  
**Project 08-Riv-10 - 30.1/44.5**

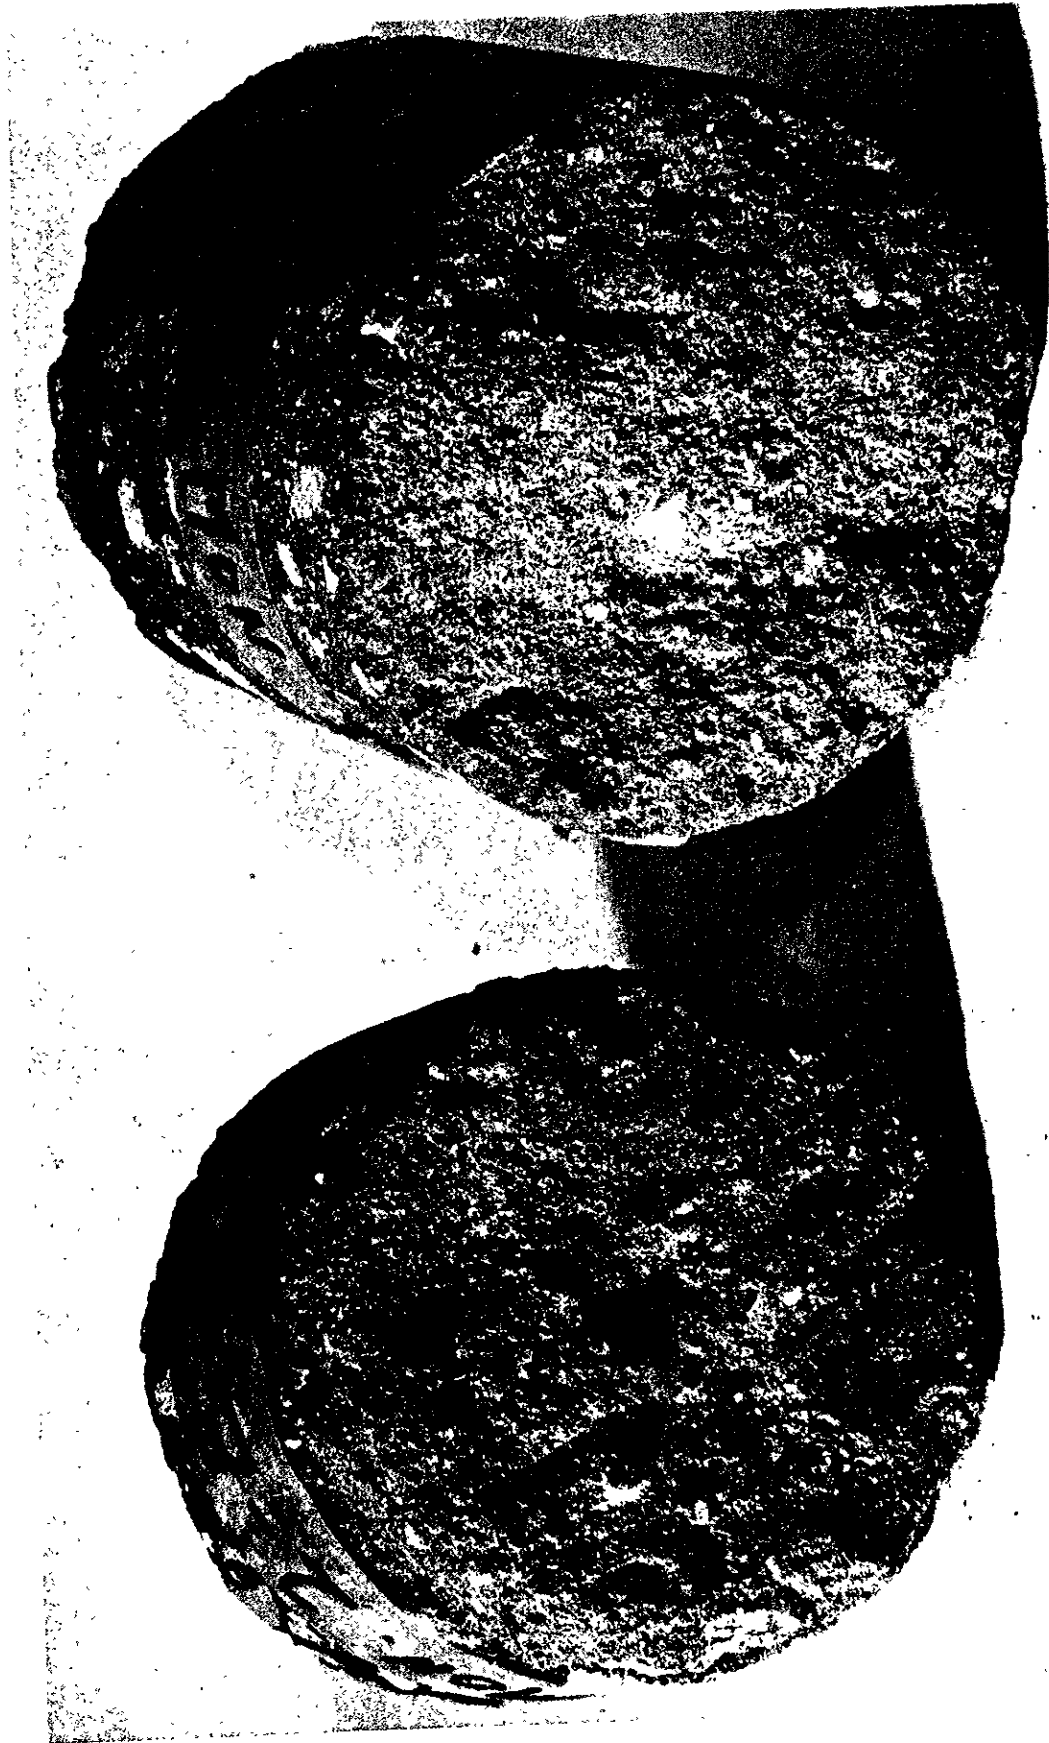
Figure 5

COMPACTION PLANE BETWEEN TWO LIFTS OF CLASS "B" CTB.

Project 05 - Mon - 101 - 43.9/51.7

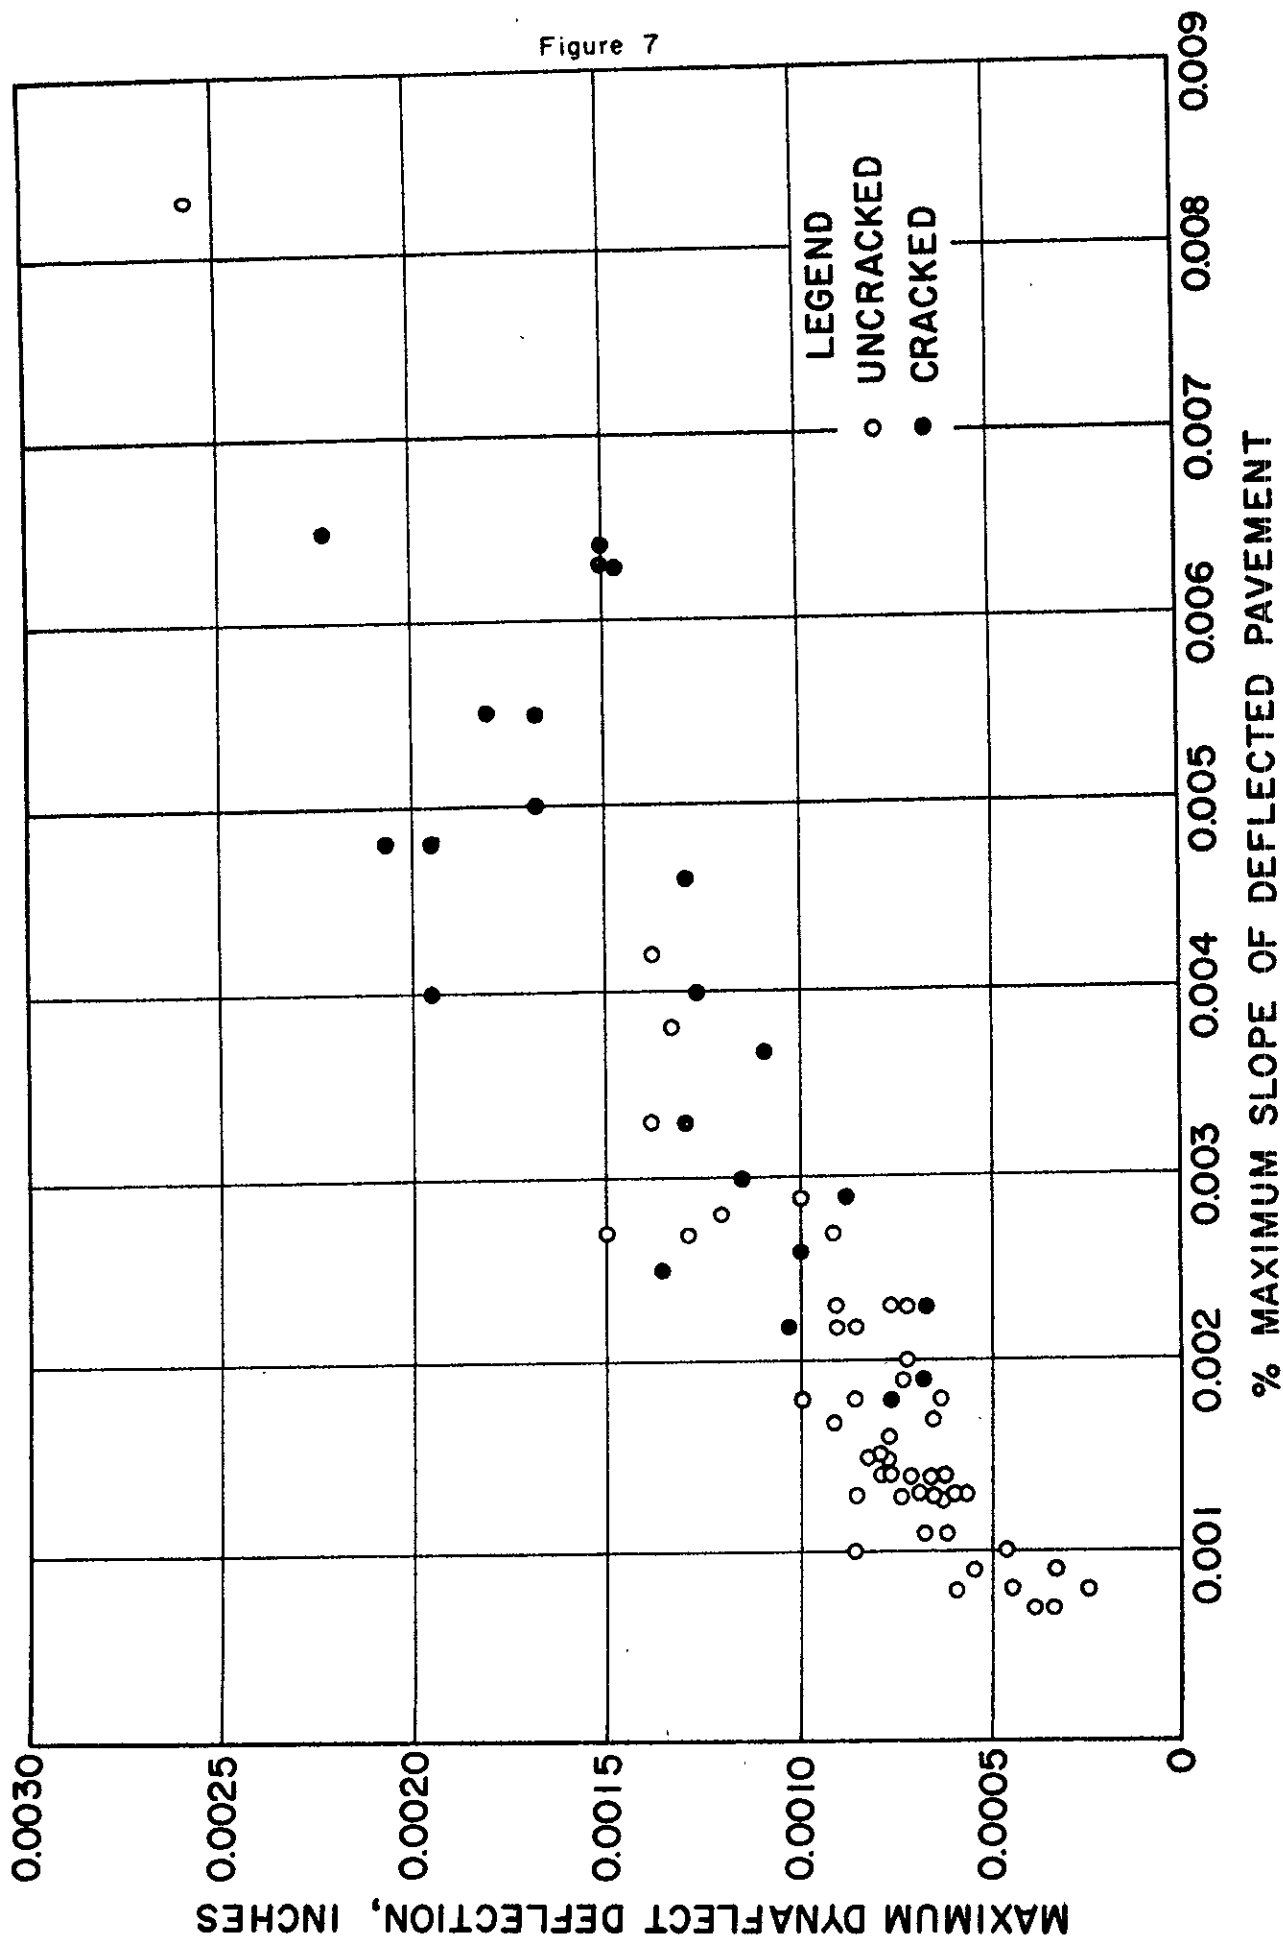
# MAXIMUM DEFLECTION VERSUS MAXIMUM SLOPE OF DEFLECTED PAVEMENT FROM DYNAFLECT READINGS

27. In order to preclude block cracking, the maximum tolerable slope of deflected California CTB structural sections between any two geophones of the Dynaflect was found to be approximately 0.002%.

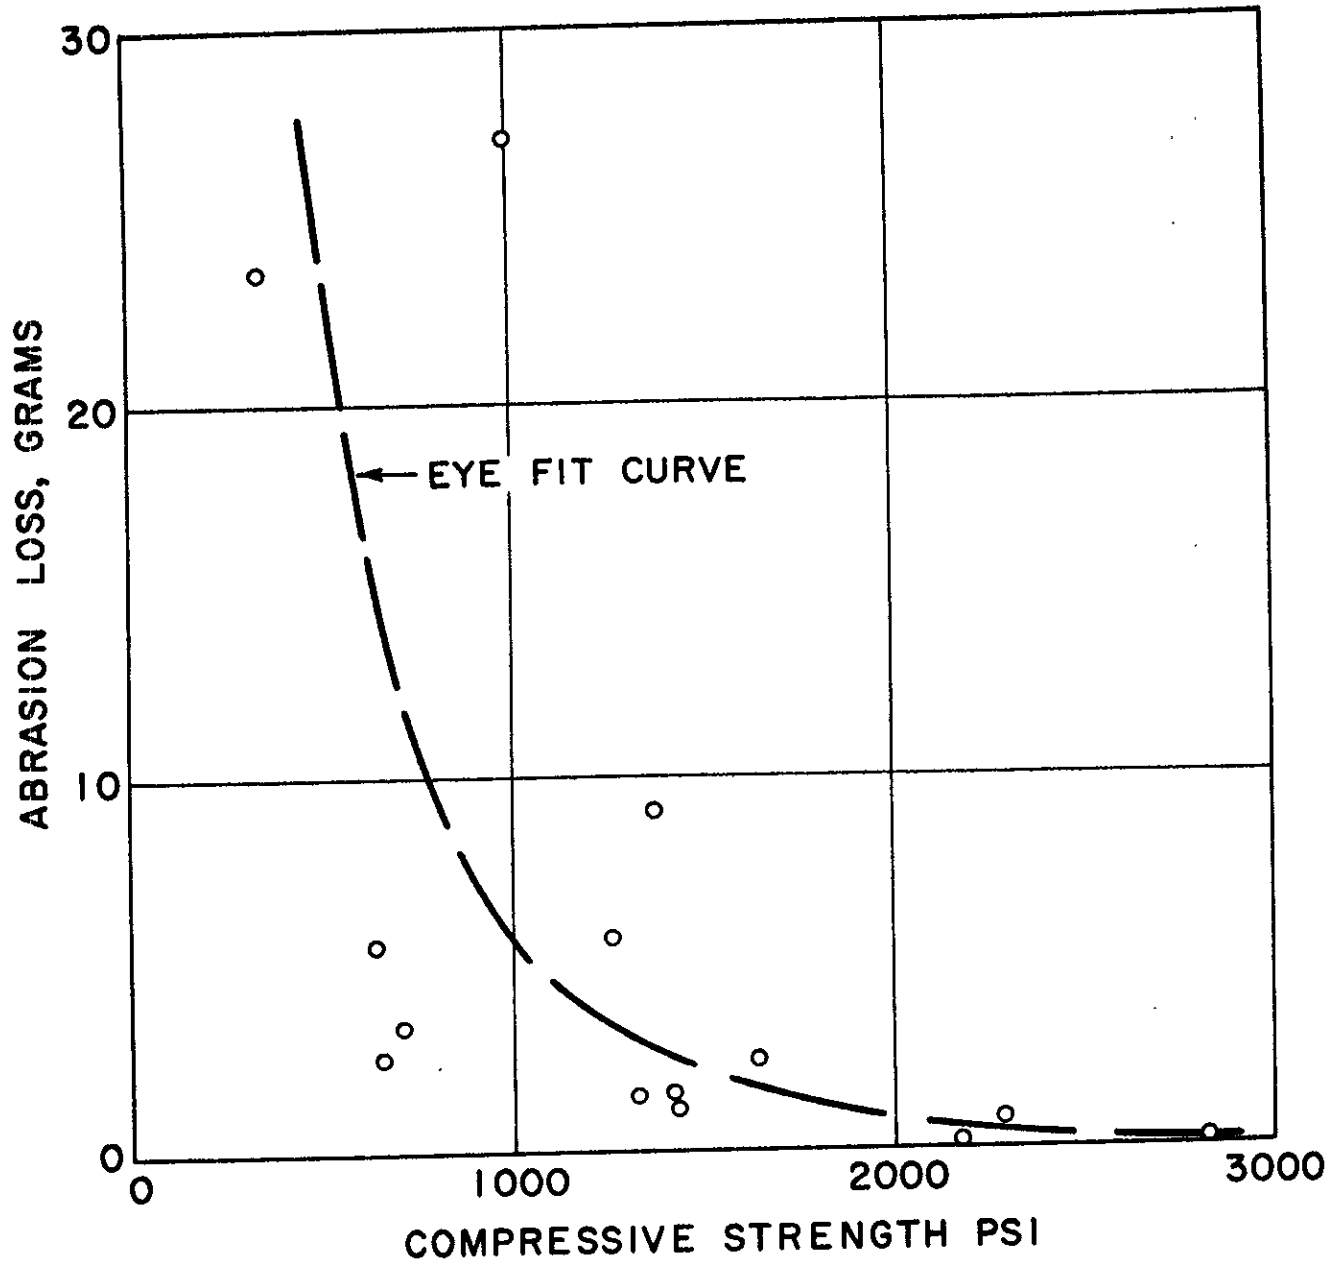
Figure 8

# COMPARISON OF CTB ABRASION LOSS WITH THE COMPRESSIVE STRENGTH OF CTB CORES

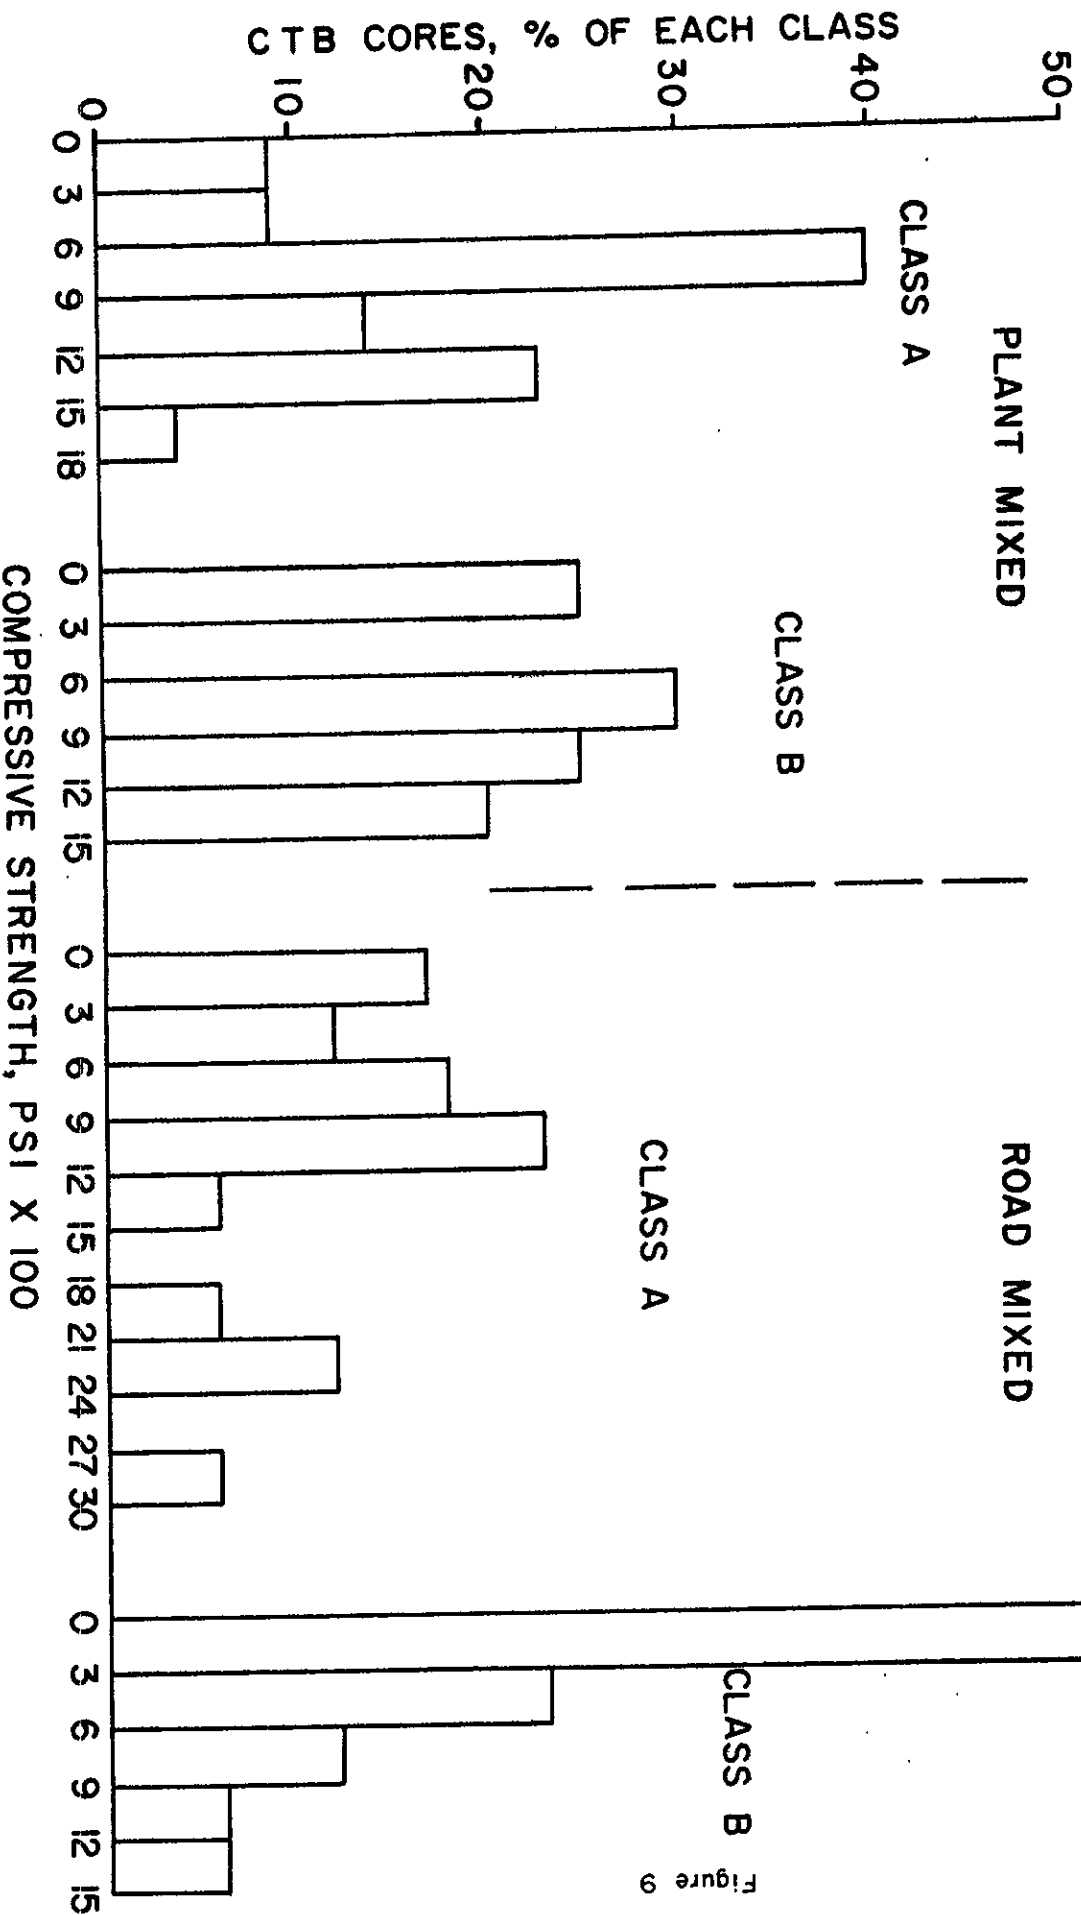
Figure 9

# COMPRESSIVE STRENGTH FREQUENCY DISTRIBUTION OF CTB CORES BY CLASS OF CTB AND TYPE OF MIXING

NOTE: UNCOREABLE LOCATIONS WERE GROUPED IN THE  
0 TO 300 PSI RANGE OF COMPRESSIVE STRENGTH

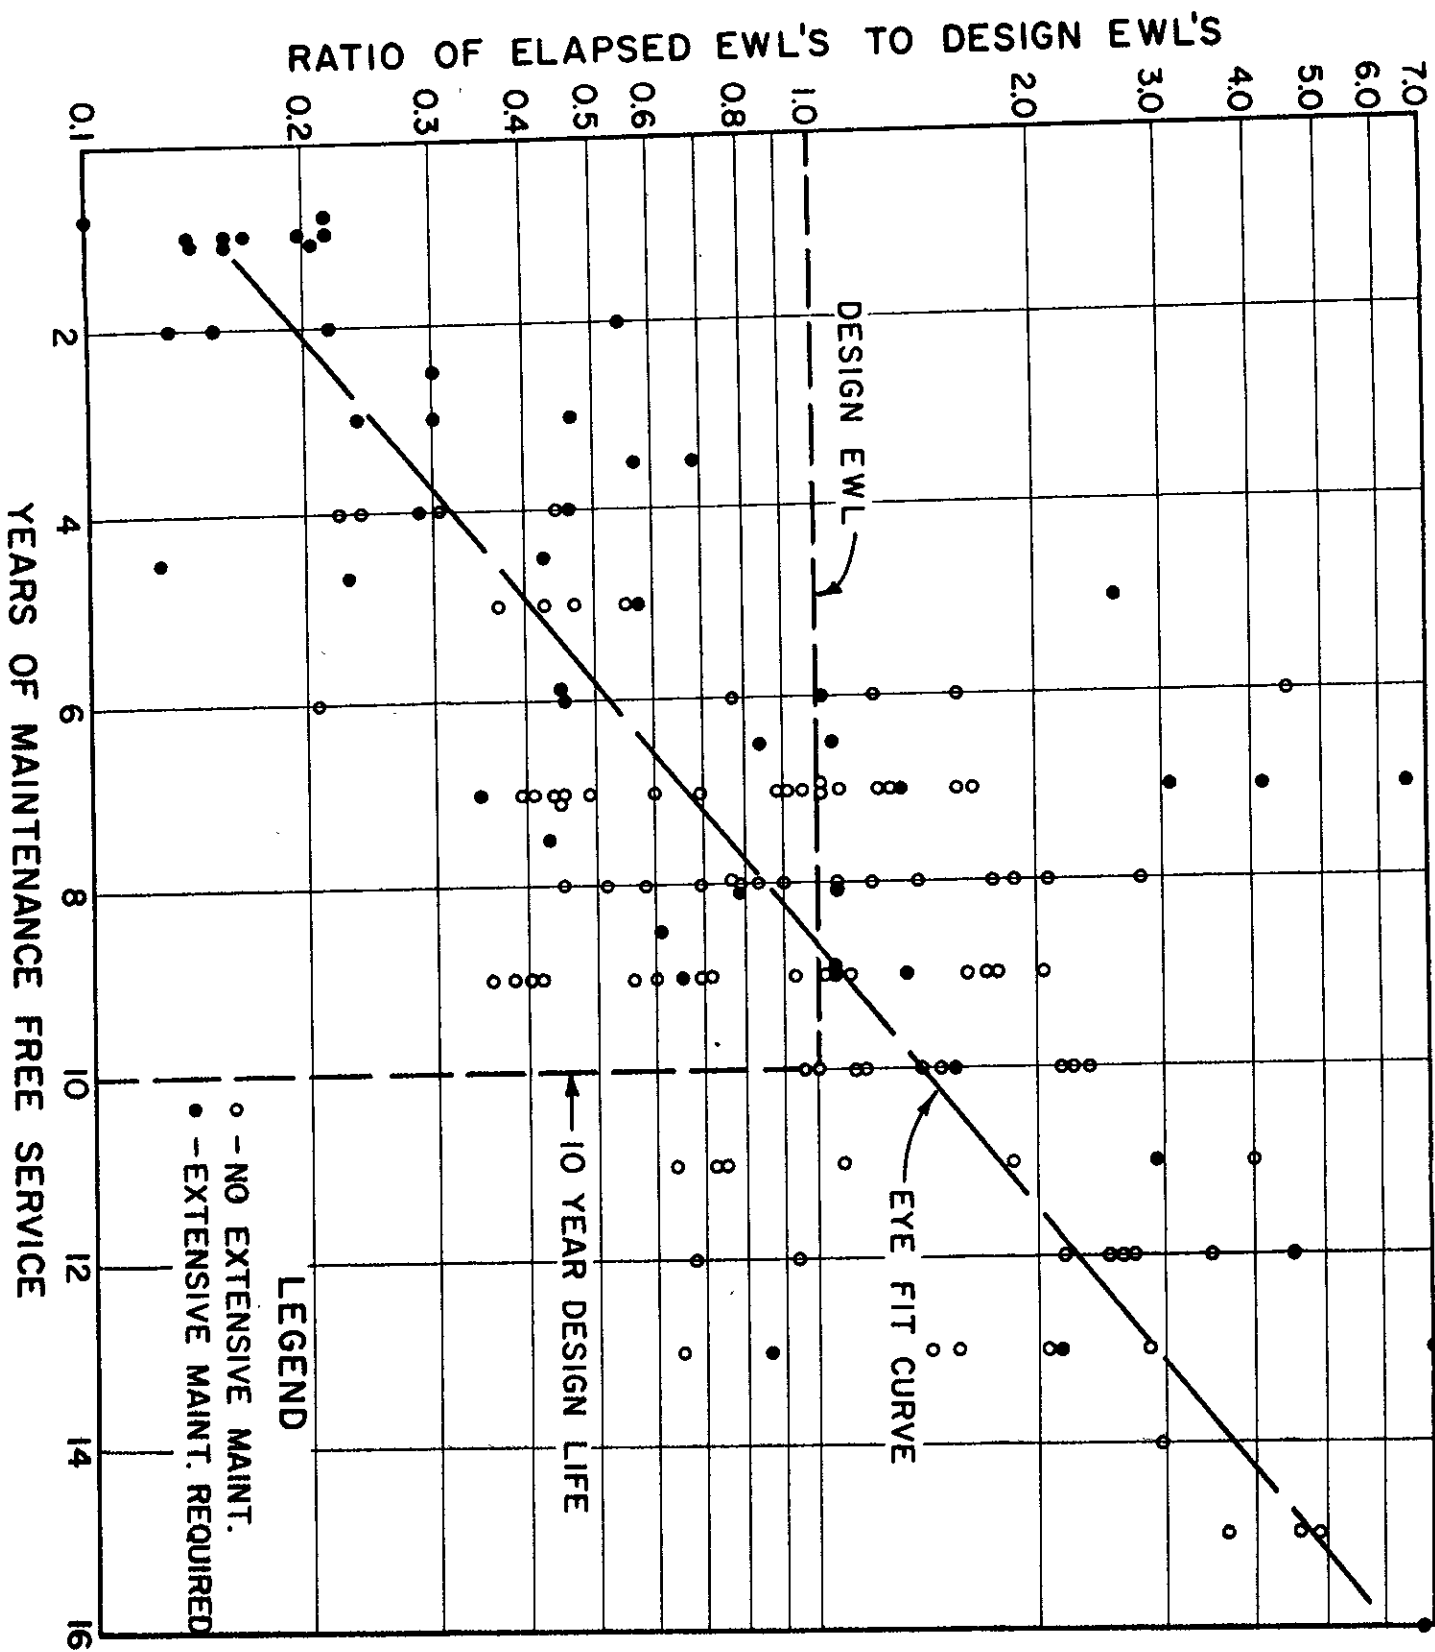
Figure 10

# RATIO OF DESIGN WHEEL LOADS ELAPSED VERSUS YEARS OF MAINTENANCE FREE SERVICE.

18. The structural sections with the strongest CTB had the longest maintenance free service life. Cracking of the CTB was not harmful when the CTB was strong enough to carry the loads.
